MEP-805B keypad stops working and how to fix it

Bill C. - 6/12/2024

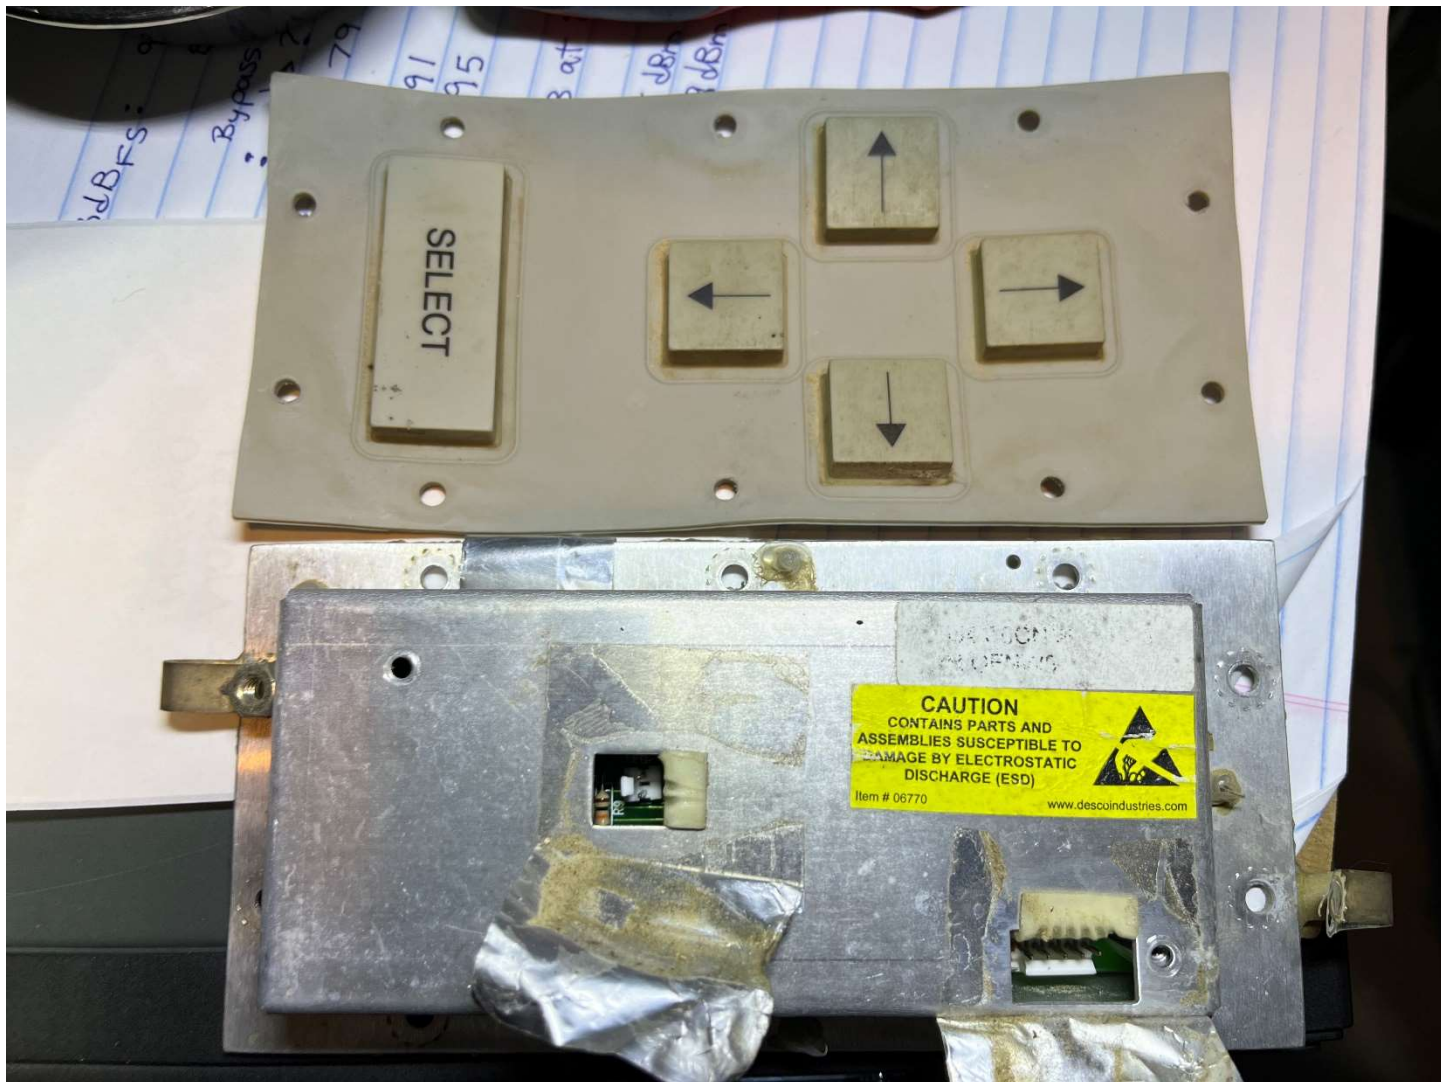
Remove the 10 screws that hold the keypad to the front panel and unplug the two connectors from the keypad module. This is easily done by peeling back the aluminum tape and unplugging the two cables from the PC board, as shown below:

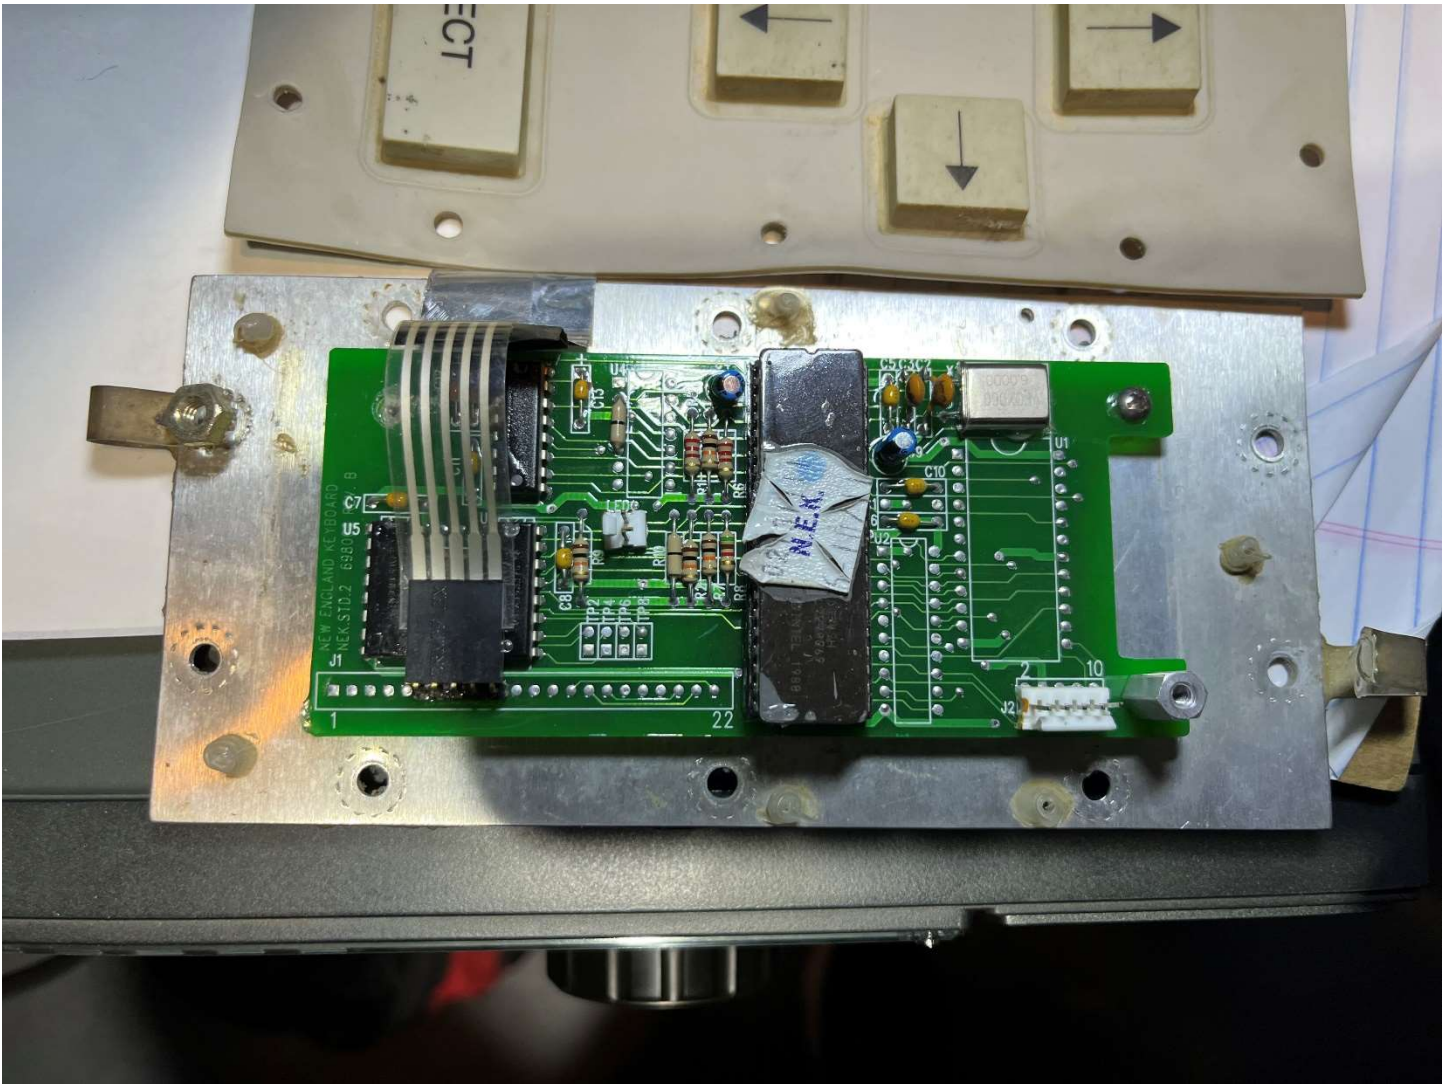
The aluminum back cover is held in place by two 4-40 screws to standoffs in opposite corners. When I removed them on my unit, the problem was immediately obvious. The larger connector in the corner has a yellow wire with a small screw lug on it so that this wire can be GNDed to the aluminum cover. It is fastened in place using the 4-40 standoff, but it had snapped-off. The aluminum cover has far too much weight to be held in place with such small hardware (4-40) and only two fasteners. There is no good way to fix this because any jarring movement or prolonged engine vibration is going to break these standoffs. The best course of action is to simply jettison the aluminum cover and do without it. You can get away with this because the whole assembly is conformal-coated inside, just like the rest of the generator electronics. Conformal-coating is commonly done to all military electronics and it offers a huge amount of protection from moisture and the elements.

When you remove the aluminum cover, it looks like this:

You can see the shiny conformal coating sprayed and/or dipped over the entire PCB.

The mesh gives the keypad a considerable amount of ESD immunity to the Human Body Model ($\pm 15\text{kV}$ 150pF 330Ω) in case the elastomeric membrane buttons fail to stop an ESD discharge. It also prevents the buttons from being activated by the mere presence of a person's charged-up finger coming near it. The mesh reduces radiated emissions from the keypad circuitry to only a small degree, because the whole module is mostly open to the outside world. It has seams and gaps and the two I/O cables connecting to it are not shielded. Suffice it to say that you can remove the aluminum back cover and do without it. This will prevent its weight from snapping the 4-40 hardware again during vibration. Definitely not a manufacturing friendly design!

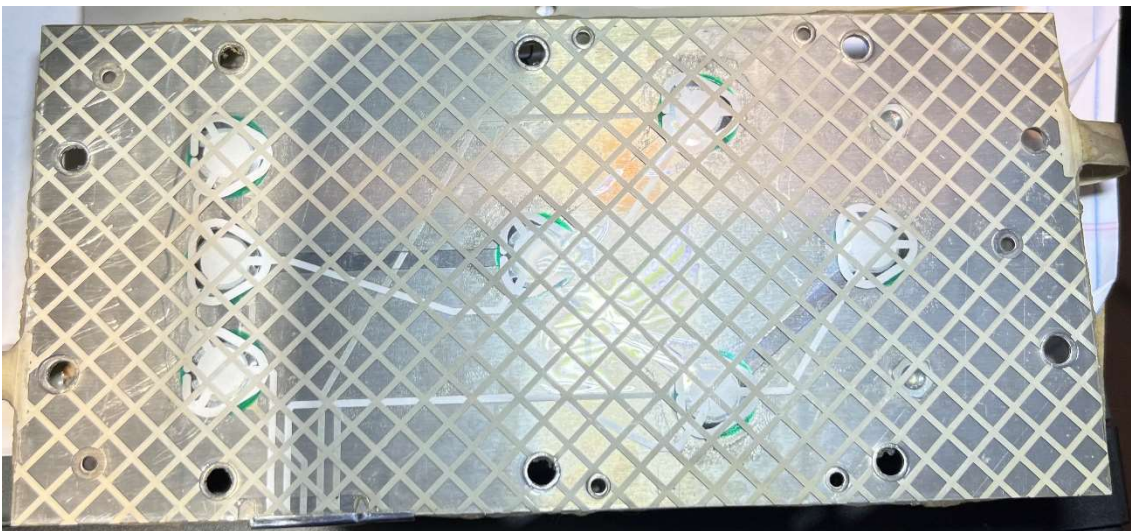
The front of the keypad looks like this:

I disconnected the flex cable running from the keypad to the PCB and verified with an ohmmeter that the keys made a proper connection. You can do this by choosing any two pins and pressing buttons until you get a low-resistance connection

indicated by the ohmmeter. If you find that one button is bad, *i.e.*, no low resistance connection on any combination of the 5 lines in the flex cable, then the keypad is bad. This can be tedious because you don't know which pin is which in the flex connector. **But please note that the keypad is not likely to fail.** Unlike the rest of the module, it appears to be very well engineered. The cross-hatched conductors are an attempt by the manufacturer to form a Faraday shield around the keypad module. This mesh connects to GND at only two of the 10 mounting screws, one at the top and one at the bottom via the feathery metal links with captive nut. The purpose of this mesh (and the aluminum back cover) is threefold: (1) ESD protection, (2) improve RF susceptibility, and (3) reduce RF emissions.

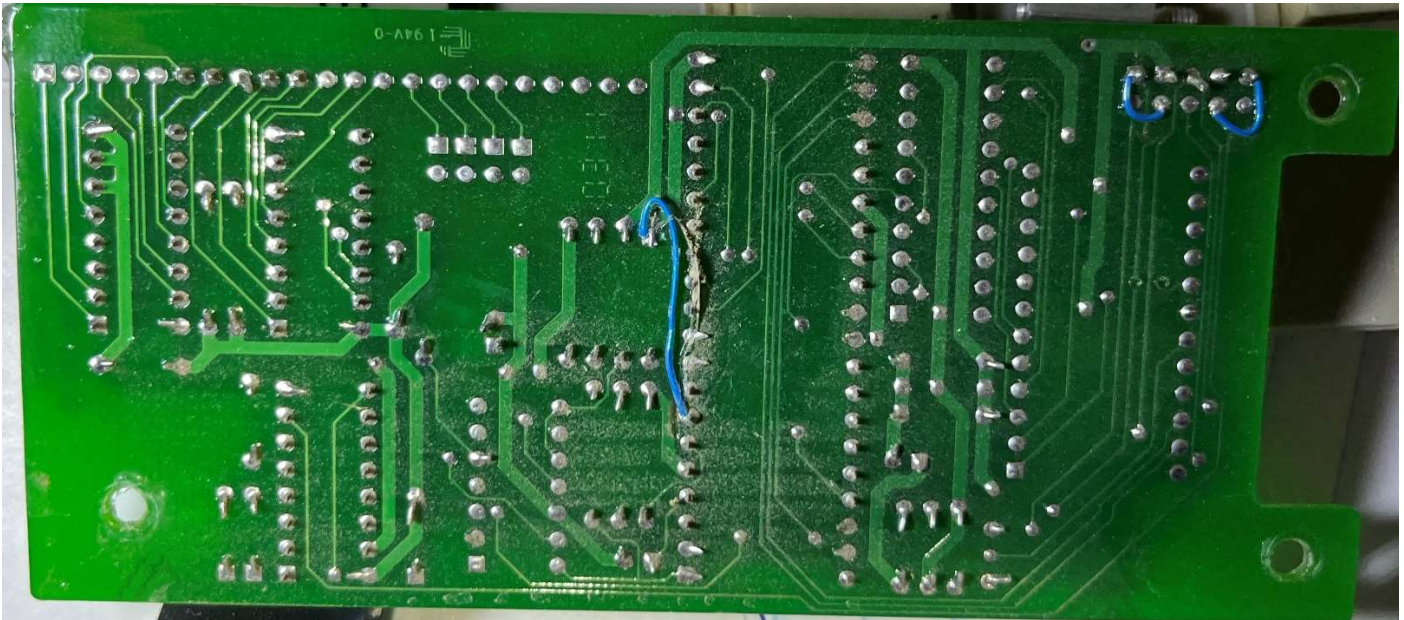
If this design weren't bad enough, there are three blue wires on the back-side of the PCB. Blue wires are used to correct a PCB layout error once the design goes into production. I can't tell if the manufacturer reused a similar design from another program and had to modify it, or if there were simply three routing errors in the layout that were never fixed. Regardless, this is simple carelessness. (I'm an electrical engineer designing electronics for over 40 years -- my designs are batting 1000 for No Blue Wires™.)

The workmanship for the blue wire in the middle of the PCB is poor. There may have been a short from this wire to a pad underneath. I had problems getting the keypad to work until I pried the blue wire up from its glue trail and moved it over slightly to the left as shown above.

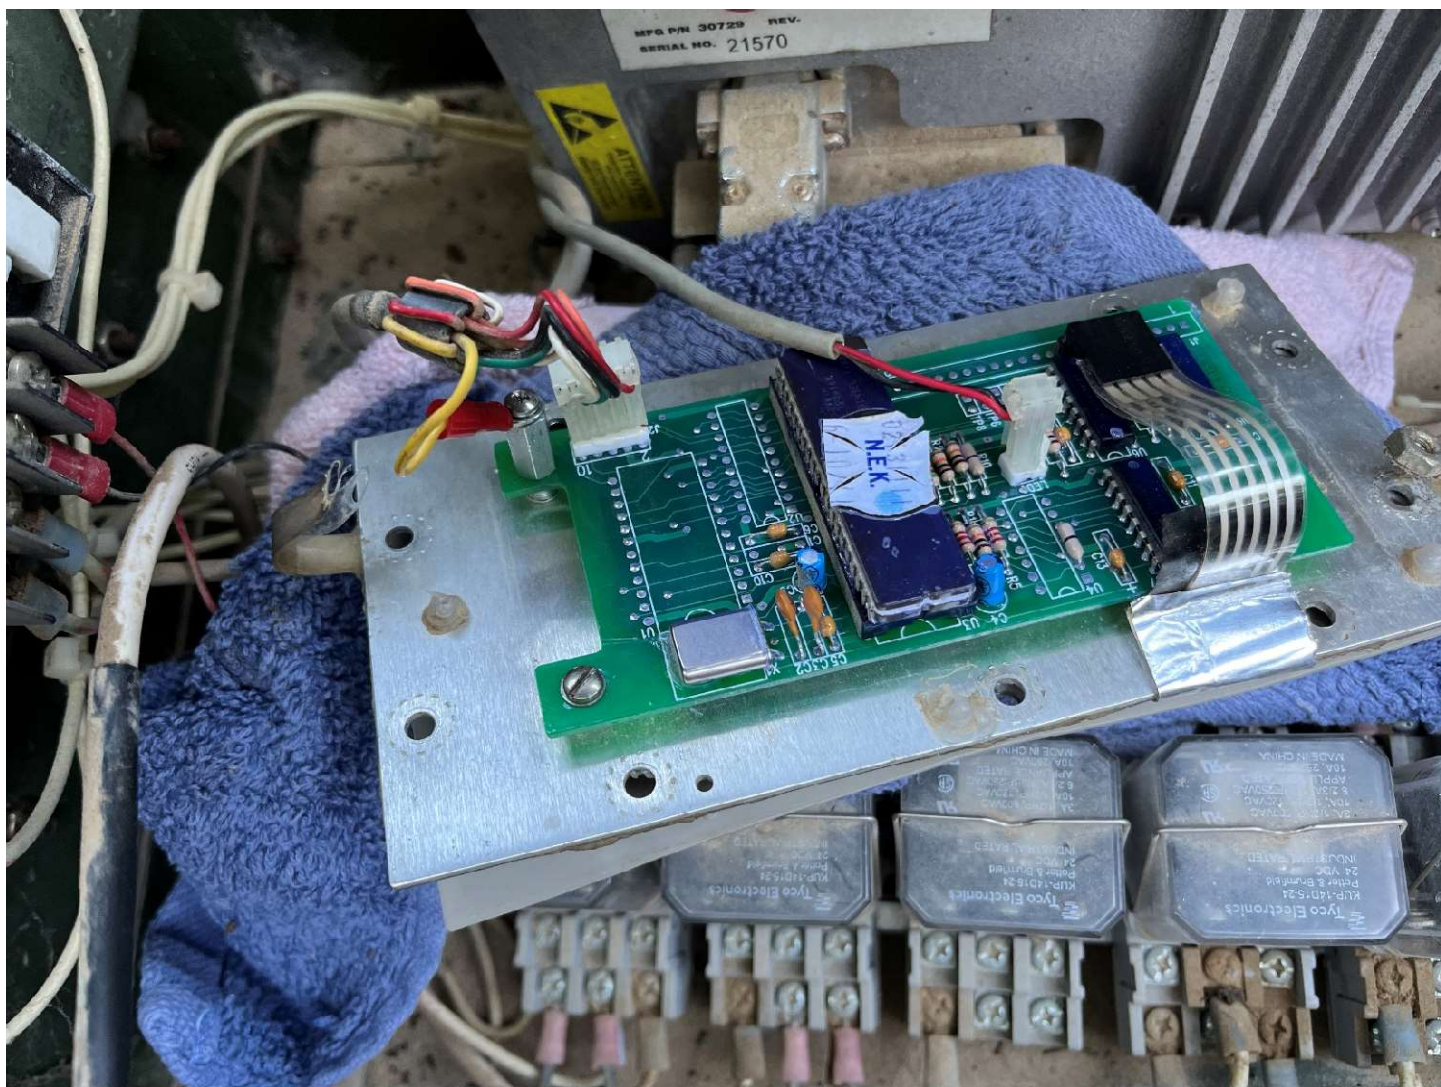
Testing of the keypad module “in situ” to see if it works:

It works! You can see the yellow wire from the I/O cable that connects to the standoff in order to make contact with GND. I found that this standoff had snapped-off when I first opened it up. The DC power cable with the black and red wires supplies +5VDC power to the PCB. Red is +5VDC and black is GND. There is a ferrite bead on the I/O cable to help suppress common-mode RF energy from radiating off the I/O cable. This can sometimes help reduce RF emissions by up to 15 dB in the VHF range. After all, you wouldn't want the enemy to track a radio emission back to your location!

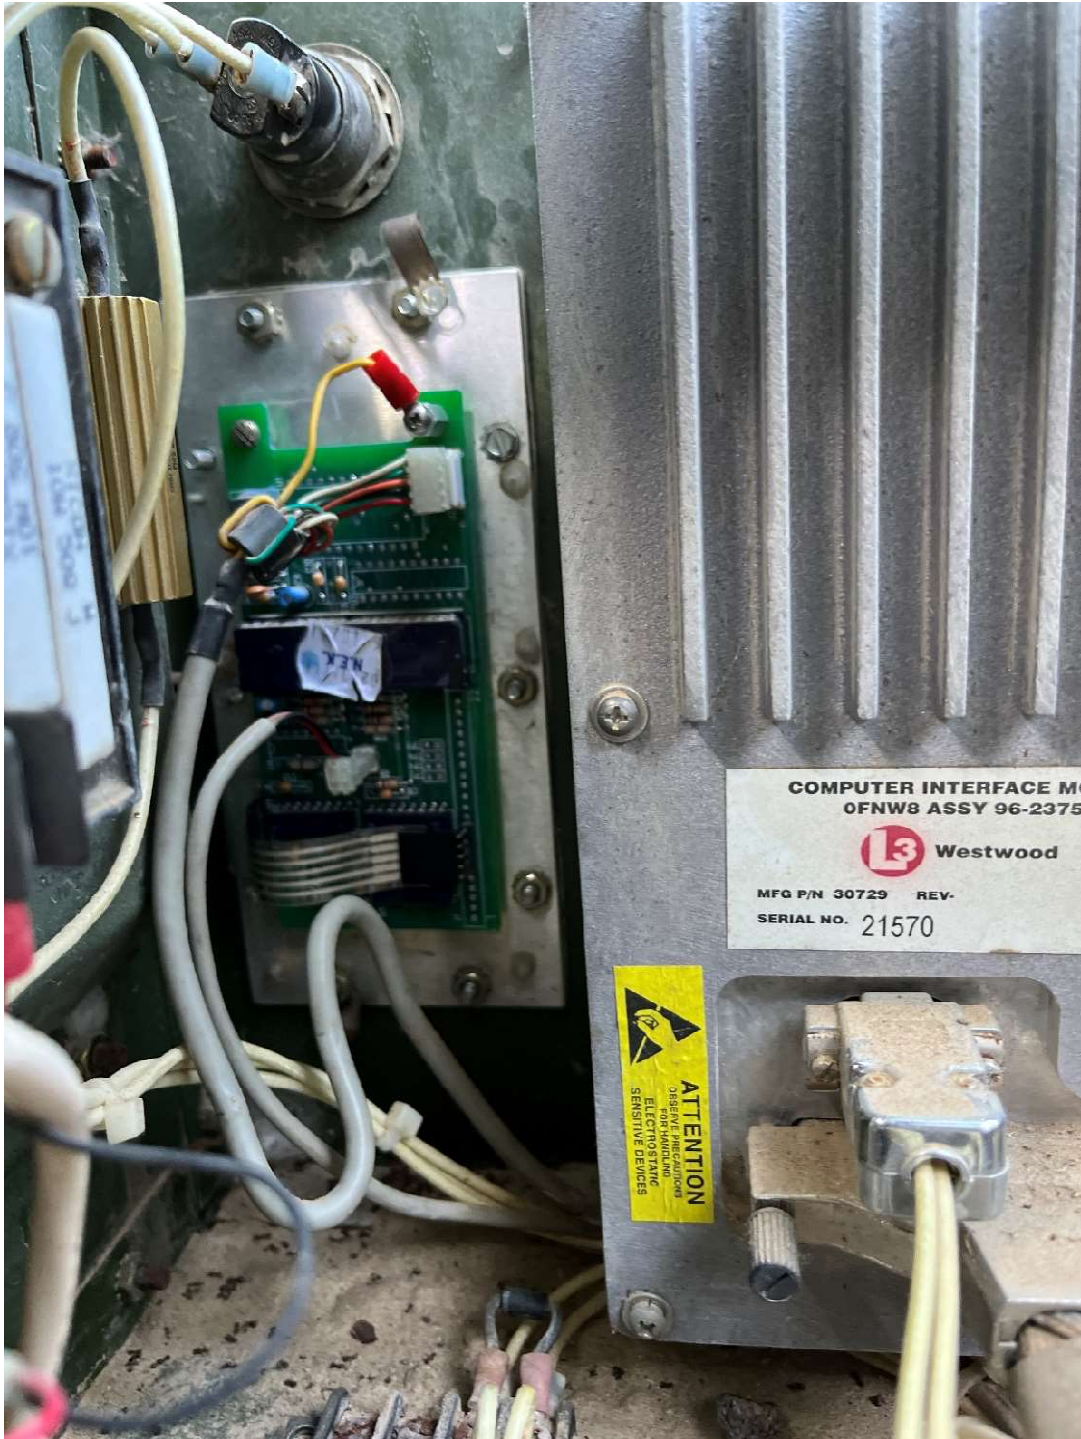
Placing the keypad back into the front panel:

The keypad went back in surprisingly easy and most of the 10 screws around the perimeter were easy to fasten. Be sure to tie-wrap the cables to other nearby cables so that they do not vibrate too much. Also keep them away from the power resistors on the side wall so that they do not get charred or melted.
